PINE BLUFF BRIDGE  
Spanning Big Walnut Creek, CR 950N  
Bainbridge vicinity  
Putnam County  
Indiana

HAER IN-103  
*IN-103*

## PINE BLUFF BRIDGE

**STRUCTURAL TYPE:** Wooden covered bridge, Howe truss

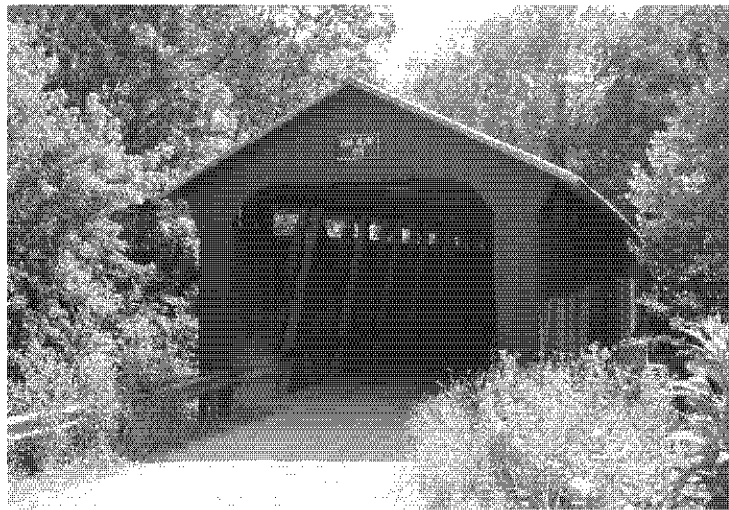
**Fig. 1: External view of the Pine Bluff Bridge from north, field photograph.**

The Pine Bluff Bridge has two spans of Howe trusses with a total length of 211'. The pier and abutments of the bridge are of cut stone laid with mortar and jacketed with concrete. The bridge has a sheet metal roof and vertical siding painted red, with two windows, one on each side of the bridge. The portals are straight with 45-degree fillets in the top corners, a typical Britton detail.

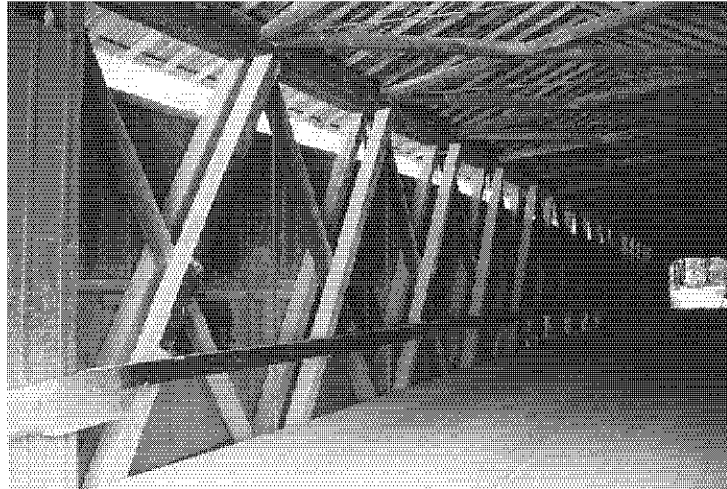
**Fig. 2: Internal view of the Pine Bluff Bridge, field photograph.**

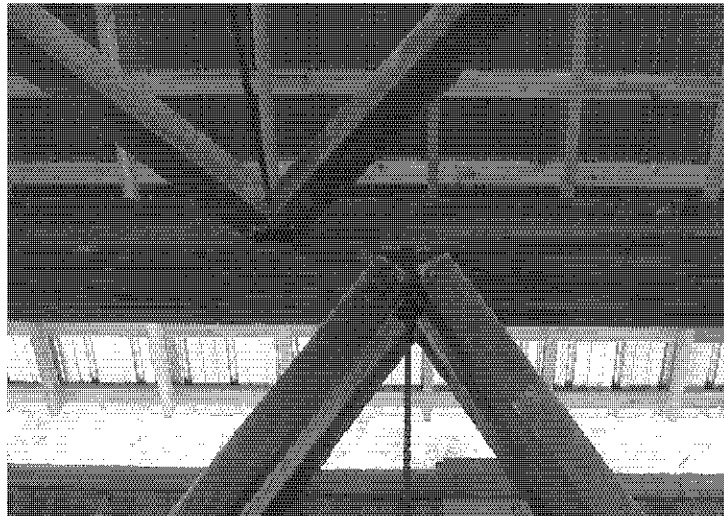
**Fig. 3: Bearing block between diagonal elements and the upper chord, field photograph.**

Unlike Howe's later, solid design (1846 patent), these bearing blocks are hollow castings, and the high bearing forces at their ribs tended to crush the wood in the chords (see Figures 4 and 5). The use of a hollow bearing block on the Pine Bluff Bridge could be due to the relative inexperience of Britton in 1886. The early Britton bridges were not as well made or precise in detail as his later ones.<sup>26</sup>

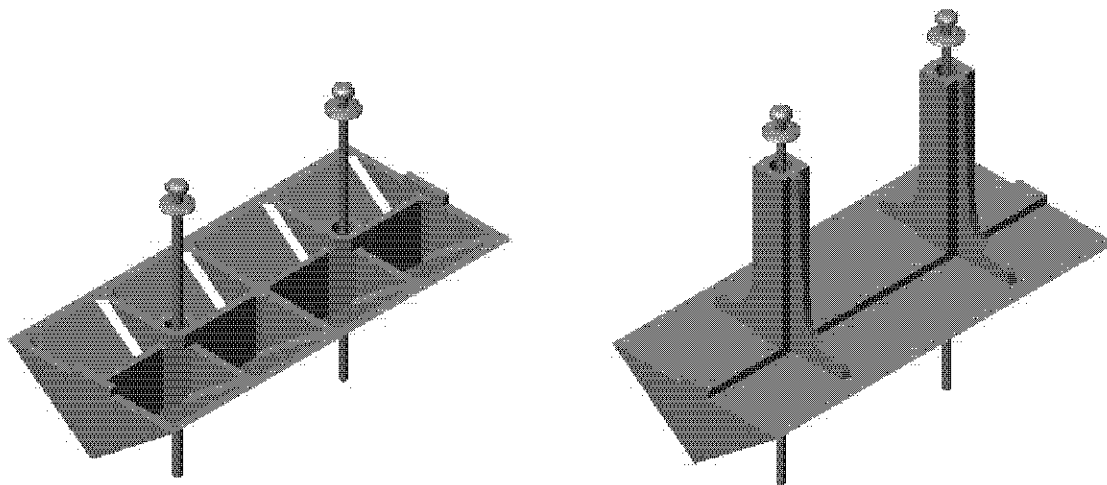
**Fig. 4: Measured hollow bearing block in Pine Bluff Bridge (left) and later solid bearing block design to prevent the crushing of chords (right).**

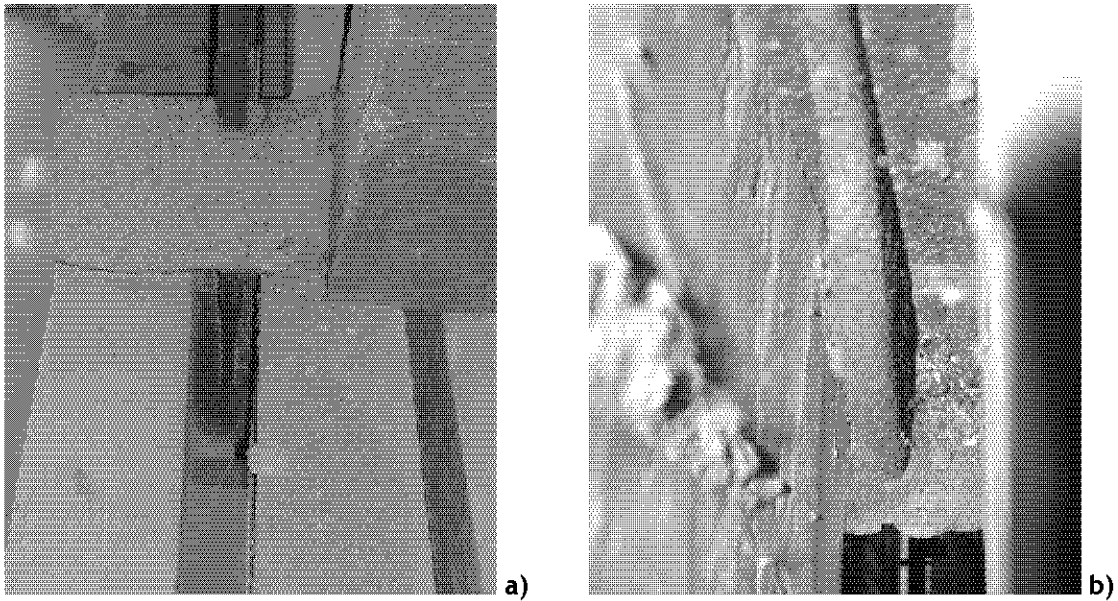
**Fig. 5: Later bearing block (a) and detail of stiffening flange in bearing block (b), Dick Huffman Bridge, Putnam County, IN, field photograph.**

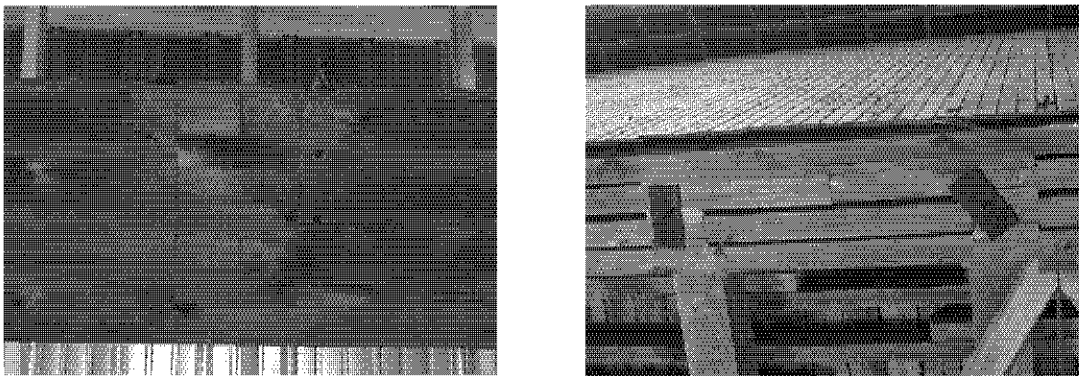
**Fig. 6: Upper chord splicing (left) and lower chord splicing (right), field photograph.**

The top and the bottom chords are made of four timbers each with overall section areas of 203 and 233 square inches, respectively. Simple rectangular wooden shear connectors splice the upper chord, while the lower chord has both rectangular shear blocks and a wooden splice (see Figures 6 and 7).<sup>27</sup>

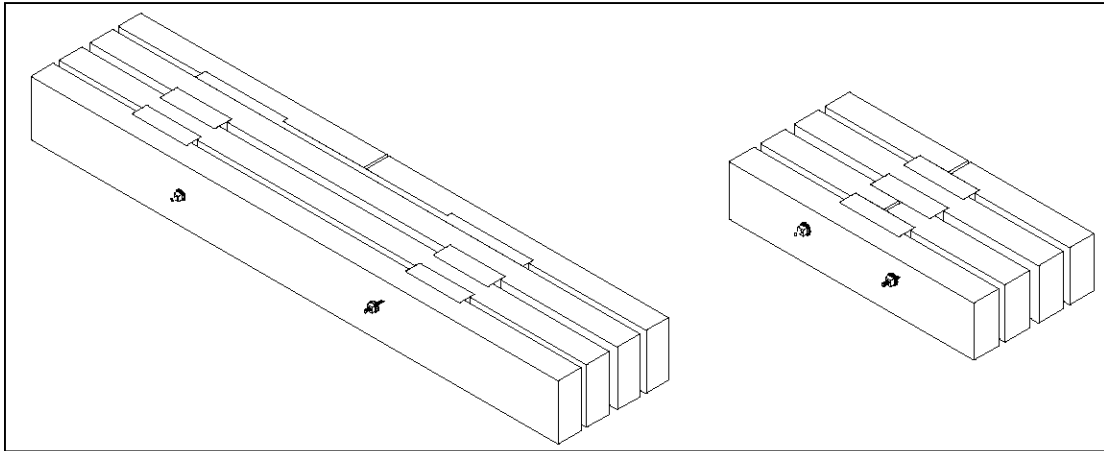
**Fig. 7: Chord splicing: lower chord (left), upper chord (right).**

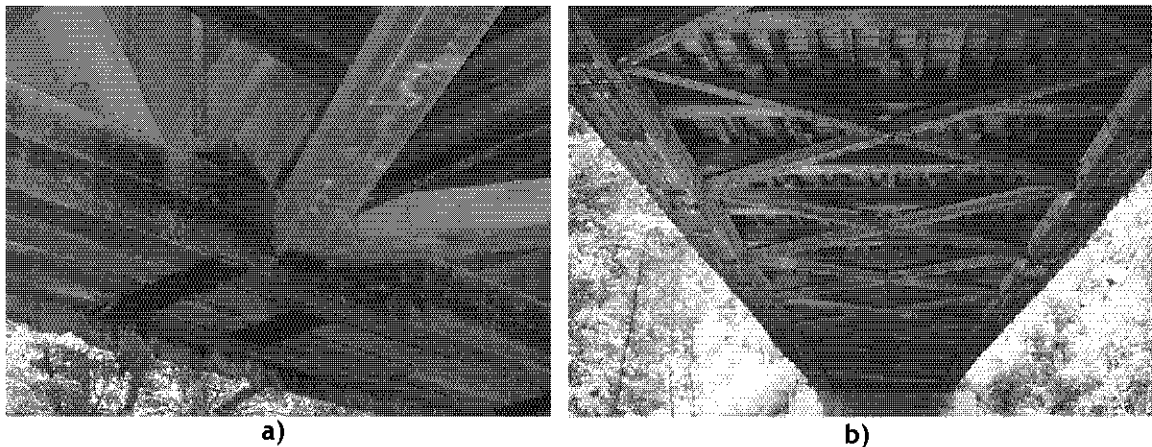
**Fig. 8: Lower lateral bracing joint (a) and general view of the decking and lower lateral bracing from beneath the bridge (b), field photographs.**

Small iron angles support the upper lateral bracing system. Each cross brace has an iron rod bolted through the chord. The lower lateral bracing is connected to the lower chord in a similar manner (see Figure 8a). Figure 8b shows a general view of the decking and lower lateral bracing from underneath the bridge.

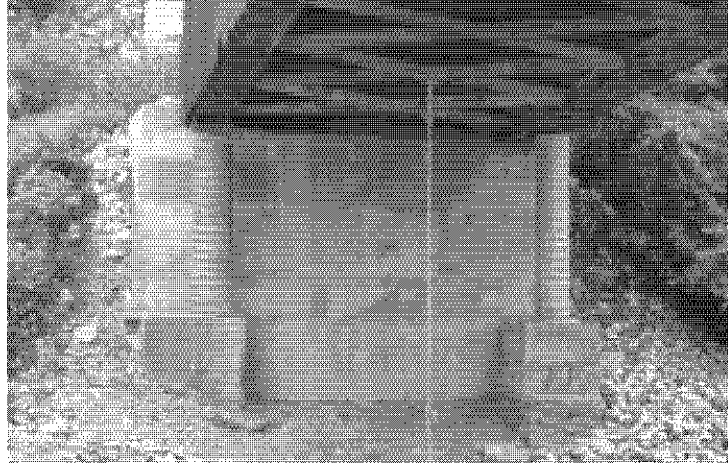
**Fig.9: View of an abutment showing the concrete jacketing of the original masonry structure and concrete pillars for lifting-up the bridge, field photograph.**

rods began in the nineteenth century. One of the first alterations, which involved concrete repairs to the substructure, was probably made in 1917.

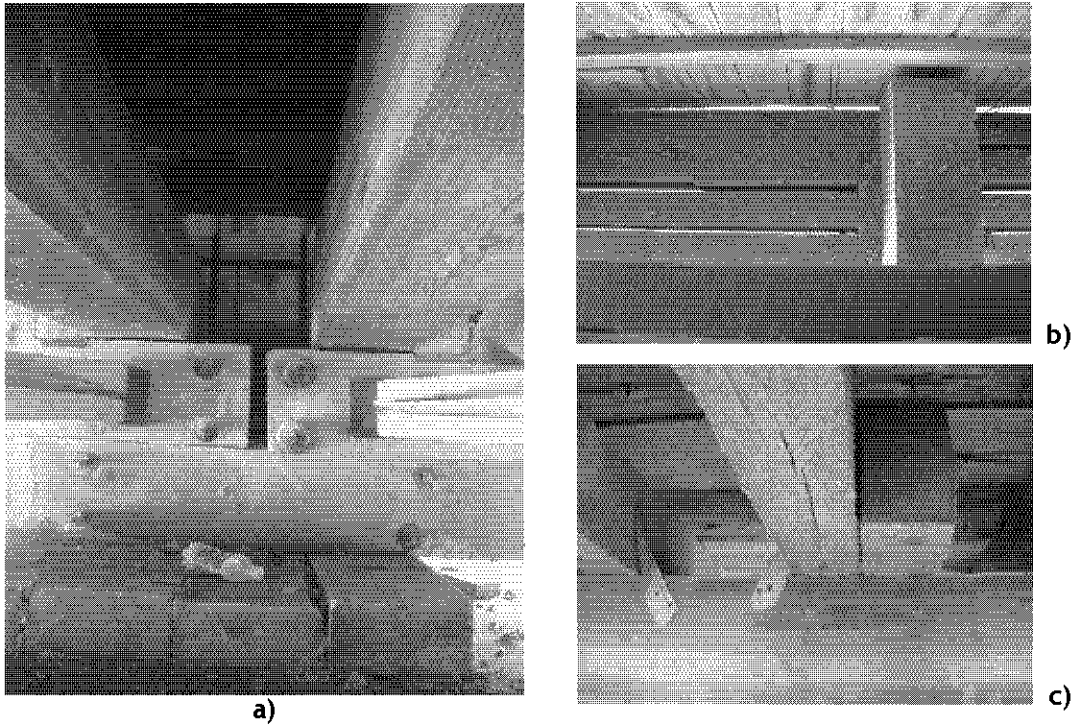
**Fig. 10: Deck bearing beams at pier support (a); glulam beam on the lower chord, view from above (b); and detail of a connection between the new deck bearing beams and the old floor beams (c), field photographs.**

In 1983, the county decided to make additional repairs to the bridge, but insufficient funds were available until 1986, when work finally started. The repairs focused on the floor system (see Figure 10), where the existing, small floor beams—probably 3x12” stringers spaced about every 2’, possibly three or four per panel—were replaced with two 11x12” glue-laminated (glulam) beams per panel. These were installed close to the posts, in non-symmetrical arrangement on the lower chord (at about 1/5 and 7/10 of the panel length). Similar repairs have been made on other Putnam County bridges. The roof has also undergone replacement.

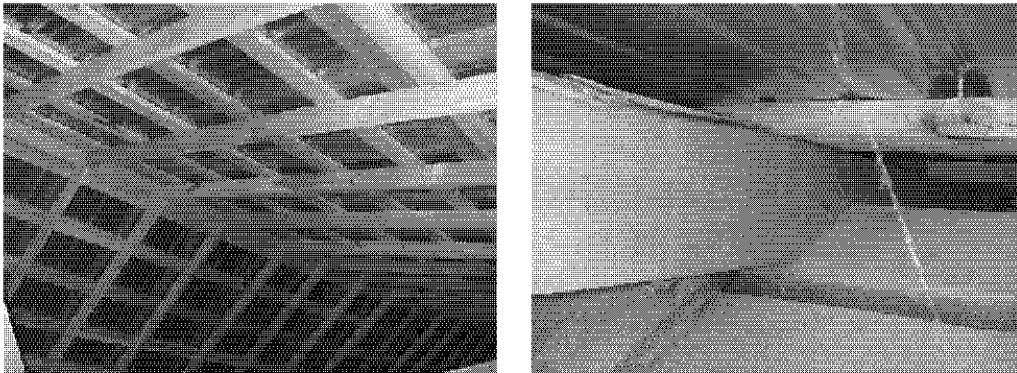
**Fig.11: View of the replaced roof (left) and connection between rafters and upper chord (right), field photographs.**

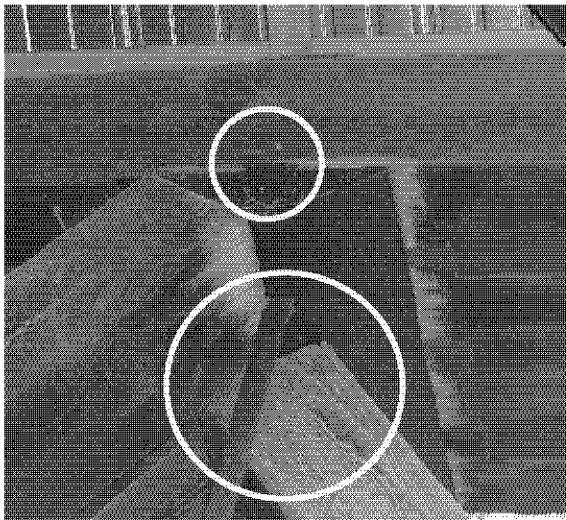
Fig. 12: Loose counter and slipping of the bearing block on the upper chord, field photograph.

An on-site inspection of the bridge from June 16 to June 18, 2002, found all the counterbraces loose and some vertical rods slack. Figure 12 shows the upper end of a counterbrace that is clearly loose. Currently, the roof rafters are simply supported on the upper chord, without ties. The deck has poor vertical alignment with the road, especially at the southern approach. Unless settlement of the south abutment occurred, it is very probably that the vertical misalignment is due to road level changes during more than one hundred years of use. Regardless of cause, this situation causes every vehicle entering the bridge to impose an unnecessary dynamic load on the structure, the severity of which increases with vehicle speed. Reducing vehicle approach speeds, if possible, would substantially reduce the dynamic effects, at least until the road surface can be better aligned with the bridge.

The lower chord timbers do not appear to have particular problems with rot, but dirt at the support and on the lower chord should be removed to minimize moisture retention.<sup>29</sup> On the upper chord, the bearing blocks have slipped about half an inch, in the direction from the main diagonal to the counter. This phenomenon, although limited, is very typical of this kind of joint.

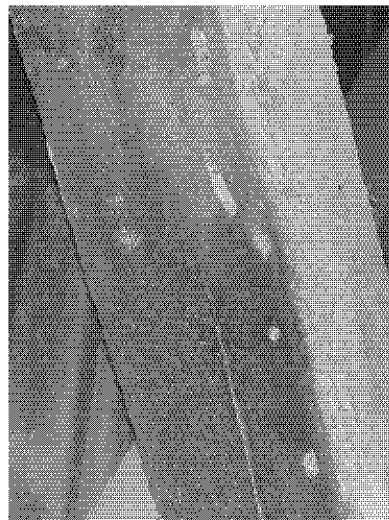
Fig.13: Insect infestation on a diagonal element, field photograph.

Some insect boreholes were noted, particularly in the diagonal elements of the truss. Figure 13 shows an example of this damage.

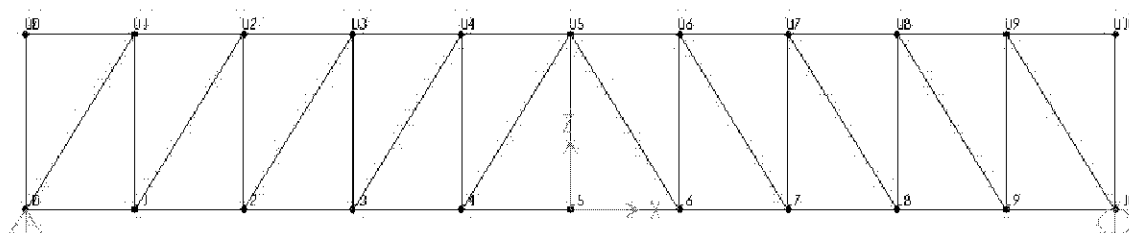
**Fig.14: Model A - Counter diagonals inactive (loose).**

Two models of the Pine Bluff Bridge were used as shown in figures 14 and 15. Model A (Figure 14) assumed the counterbraces were loose. This model reflects the actual condition of the bridge, as verified during the on-site inspection. Model B (Figure 15) assumed that, because of prestressing, the counters could act both in tension and in compression. The frame models were symmetric, so, as expected, symmetric loading conditions caused symmetric responses of the models.

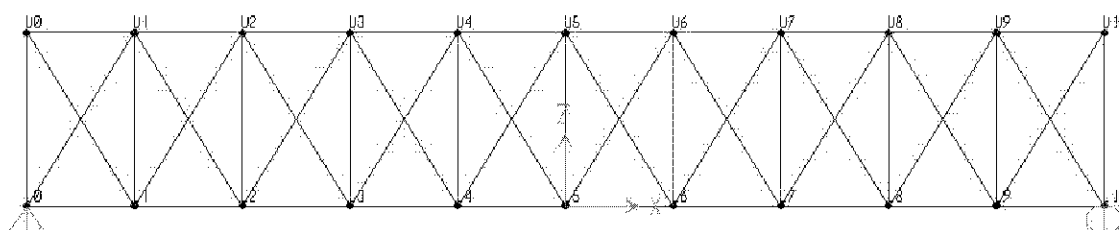
**Fig.15: Model B – Counter diagonals active (sufficiently prestressed by wedges).**

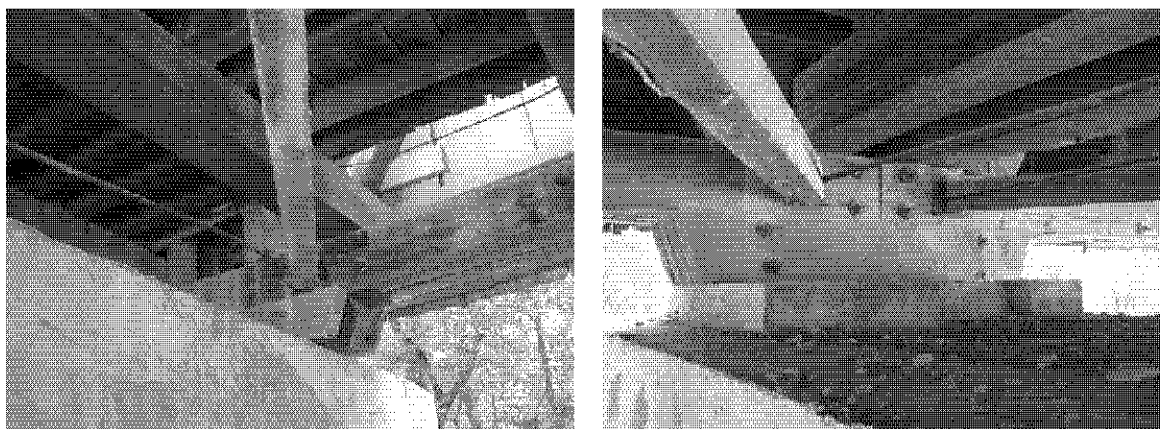
**Fig. 16: Detail of the supports at the abutment (left) and at mid-span on the pier (right), field photographs.**

Concrete jacketing strengthened the original stone bridge abutments and pier. A site inspection of the bridge revealed that the spans were simply supported on wooden beams (four per each bottom chord). At the abutments these beams are fixed in concrete. These supports (see Figure 16) can resist not only vertical displacements but also horizontal ones and were therefore modeled as pins. On the contrary, at mid-span, the wooden truss is actually simply supported on beams on the central pier and some degree of horizontal displacement is allowed. These supports were thus modeled as roller-type connections.

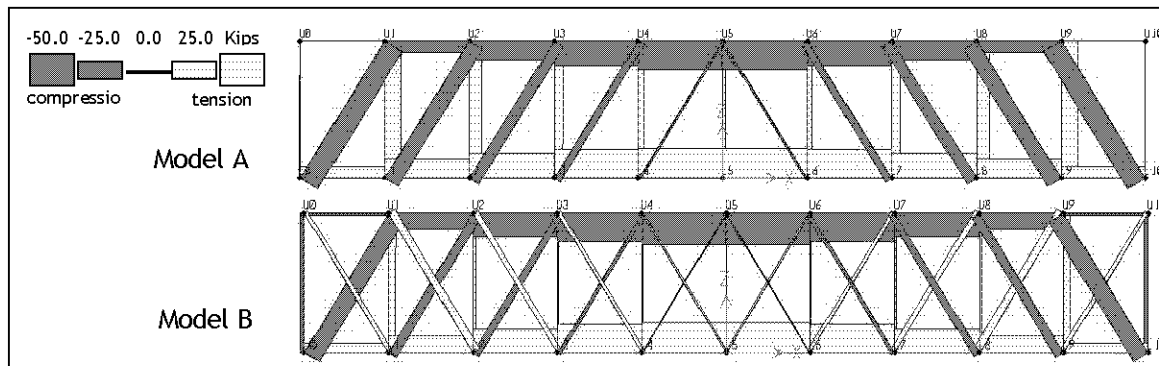
Fig. 17: Axial forces under dead load in the frame members of the two models.

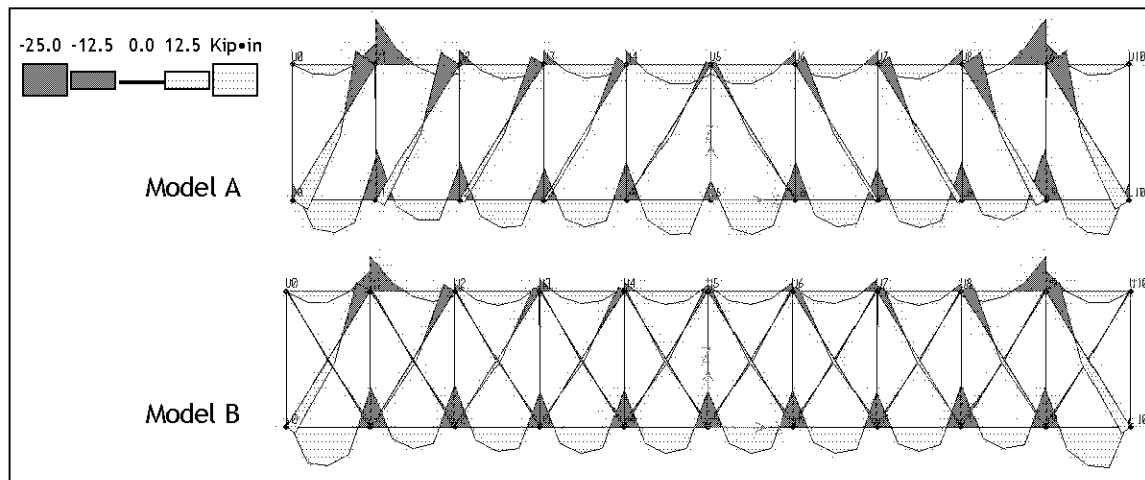
Fig.18: Bending moments under dead loads in the frame members of the two models.

For all the elements, the maximum absolute values of bending moments and shear forces are reached in members close to the bridge ends (see respectively Figures 18 and 19). A summary of the forces in the main elements of the truss models A and B can be found in Table 3.

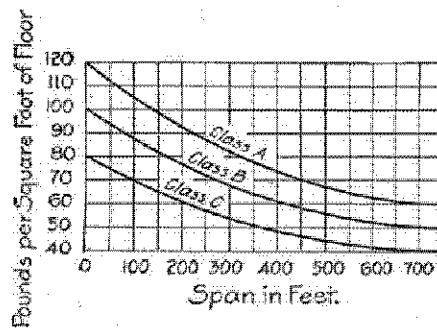
Fig. 22: Waddell's live loads for highway bridges.<sup>34</sup>

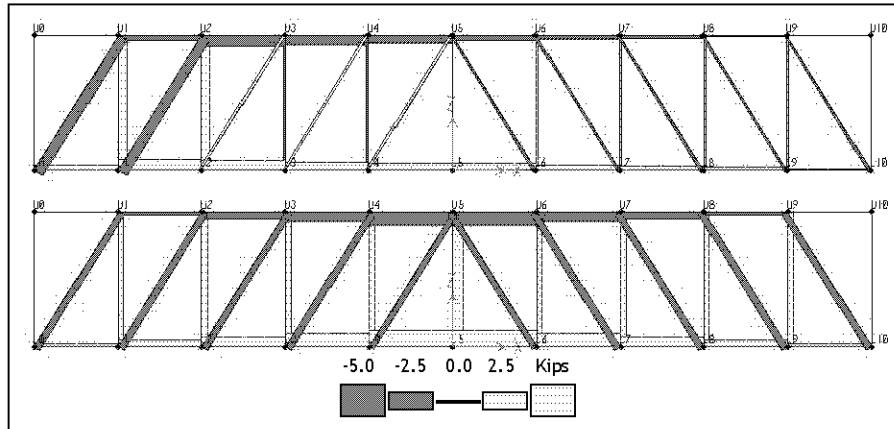
Fig. 21: Model A: axial forces under live loads applied at L2 and L5.

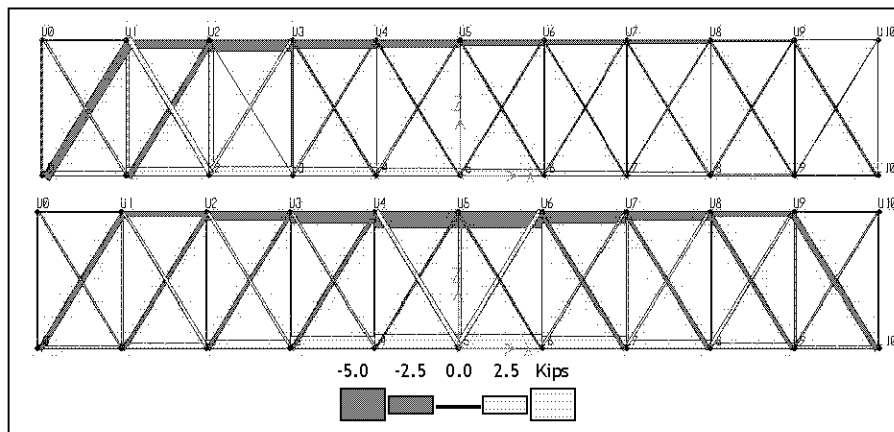
Fig. 22: Model B: axial forces under live loads applied at L2 and L5.

Figure 22 shows that the live load at L2 produces tensile forces in both main diagonals and counterbraces. A uniformly distributed load over a half-span also produces tensile forces in main diagonals and counterbraces, as can be seen in Figure 23. Therefore, to prevent diagonals from becoming loose, the combined action of dead load and prestressing (tightening of vertical rods) must produce compressive forces that exceed the tensile forces produced by design live loads.

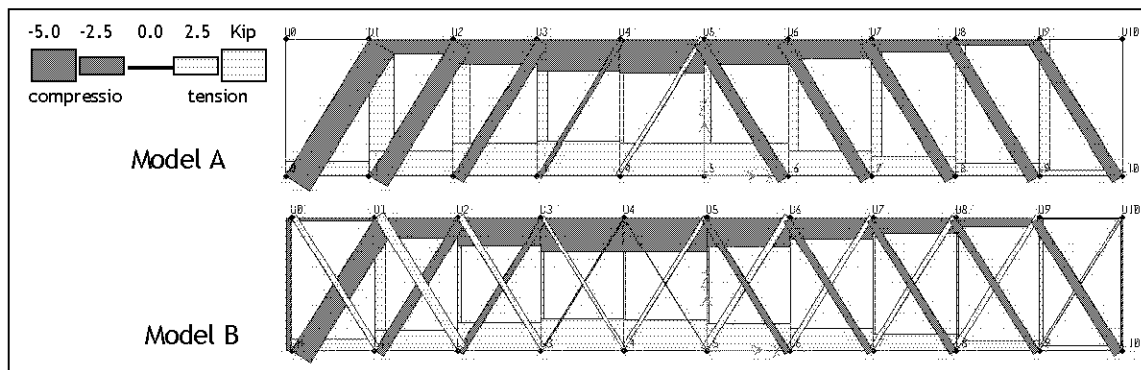
Fig. 23: Model A and Model B: forces under a uniformly distributed live load over one-half of span.

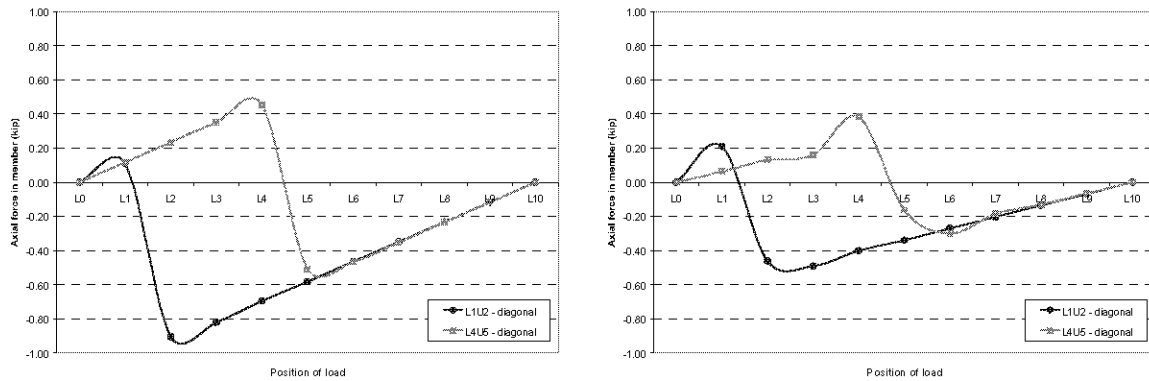
**Fig. 24: Model A (left), Model B (right): influence lines of three diagonal members, showing the axial force under a unit live load as a function of load position.**

Figure 24 shows that a live load can cause both tensile and compressive forces in the main diagonals. Forces in the diagonal elements of Model B were lower than those of Model A, because of the presence of the counters. Figure 25 shows that a live load causes mainly tensile forces in the counterbraces.

The influence lines for the main diagonal members show that the element subjected to the highest axial tension force for the action of a live load application was L4U5, that is to say the mid-span diagonal, when load was applied at node L4. Since the central diagonals are the members subjected to the lowest axial compression due to dead load, they are the members at greatest risk of a zero net axial force due to combined dead and live loads at L4, with the corresponding loosening of diagonal L4U5. Due to the symmetry of the structure, this also applies for diagonal L6U5 when a live load is applied in L6.

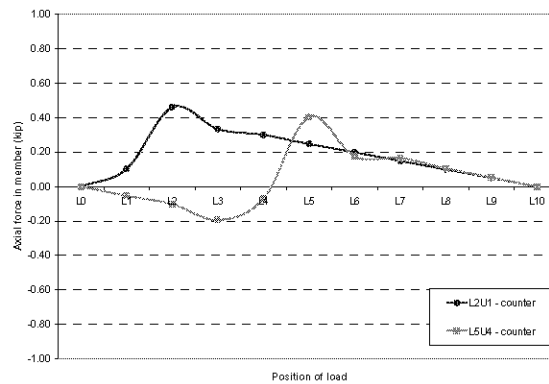
**Fig. 25: Influence lines of two counters, showing the axial force under a unit live load as a function of load position.**

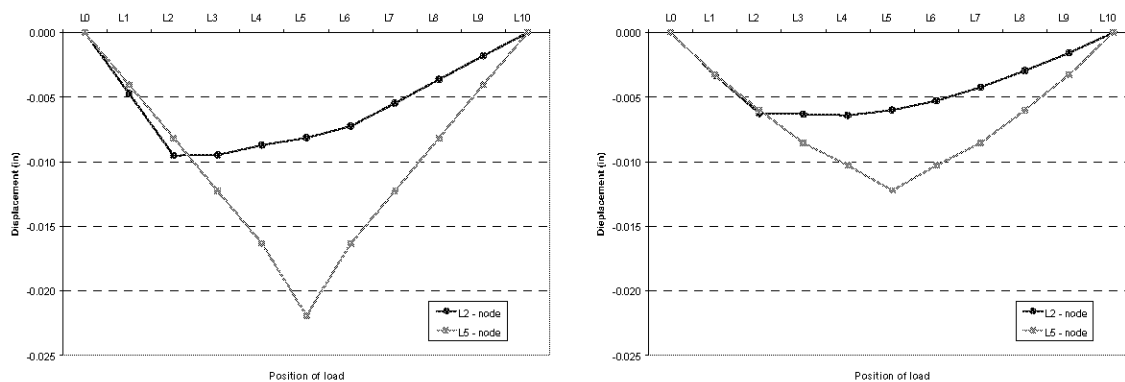
**Fig. 26: Models A (left) and B (right): influence lines of three nodes of the lower chord, showing the displacements under a unit live load as a function of load position.**

Figure 26 shows the vertical displacements of two panel points on the lower chord (L2 and mid-span point) for different live loads positions. When the live load was moving from the first panel point to a particular node, the node displacement increases more or less linearly. Correspondingly, when the load was moving away from the node, a nearly linear decrease of displacement occurs, except for node L2. Figure 26 also clearly shows that the displacements obtained with counterbraces (Model B), were lower than those without counterbraces (Model A).

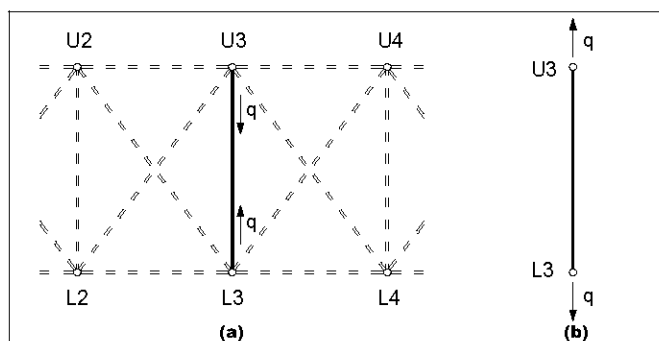
**Fig. 27: Effective nodal loads from tightening a vertical rod (a); corresponding fixed end forces on the rod (b).**

concurrently. The prestressing action of tightening the nuts was modeled by applying additional loads at the nodes and in the directions of the elements being shortened, assuming all nodes were fixed. For example, if vertical element L3U3 is being prestressed the effective nodal loads are as shown in Figure 27.

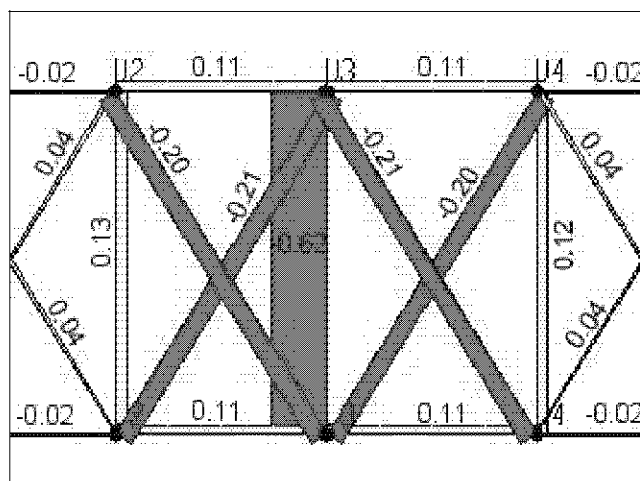
**Fig. 28: Axial forces (kips) from effective nodal loads by prestressing element U3L3. The total force in element U3L3 is found by adding the fixed end force, +1 kip.**

Figure 28 shows axial forces in a portion of the model centered on the vertical rod L3U3, due to effective nodal load from tightening the rod. The rod, L3U3 in this example, was subjected to an axial compressive force of -0.62 kip due to the effective nodal loads and to a fixed end tensile force of 1 kip, for a total actual axial tensile force of 0.38 kip. The two adjoining diagonals and counterbraces were precompressed with an axial force more or less equal in absolute value to half of the axial force acting in the vertical rod (about -0.21 kip). Conversely, the other rods of the two adjacent panels (in average 0.125 kip) and the chords (0.11 kip) were in tension. The distribution of axial forces in the different elements obtained by tightening the rods is a function of the panel's geometry.

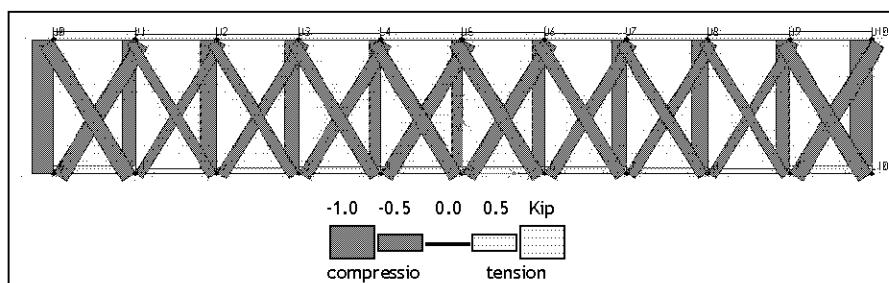
**Fig. 29: Axial forces from effective nodal loads from prestressing all the counters. The total force in the verticals is found by adding their fixed end force, +1 kip.**

Figure 29 shows the axial forces from effective nodal loads from prestressing all the vertical elements. The actual axial forces in the rods were found by superposing the fixed end forces to the axial forces produced by the effective nodal loads. It is uncertain how the end rods were tightened, so it was assumed that rods L0U0 and L10U10 were prestressed with the same force used for the other vertical elements.

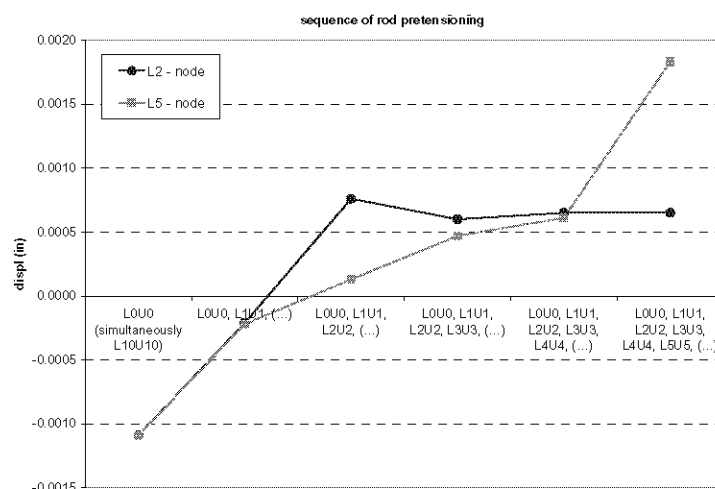
Fig. 30: Nodal displacement of the lower chord, with the progression of tightening rods.

For the 1 kip effective load, the displacements are very small relative to the predicted dead load displacements. Because of this, if the rods are tightened with falsework in place, the prestressing action will only slightly relieve some of the dead load forces on the falsework. Also, because dead load produces tensile forces in the counters, a truss should be prestressed after the falsework has been removed and the dead load is being carried by the truss alone, although the nut tightening may require more effort.

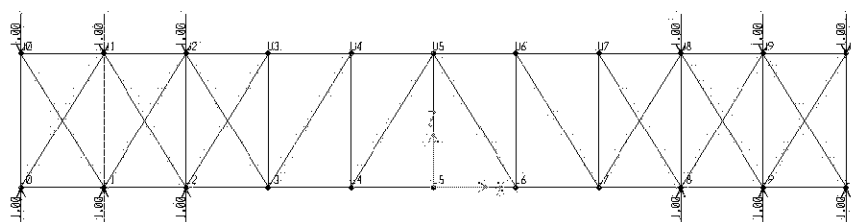
Fig. 31: Model used to evaluate lower chord displacements at the third step of the prestressing sequence.

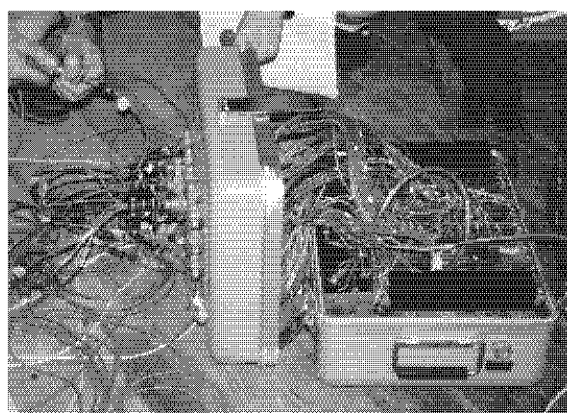
**Fig. 32: Data logger for experimental data acquisition, field photograph.**

The test equipment consisted of fourteen strain transducers, with a 5-inch gauge length, four electrical resistance strain gages, one inductive displacement transducer (DCDT), and a potentiometer (also used for displacement measurement). A multi-channel data logger (Figure 32) was used for the collection and the analog-digital conversion of the data. This was connected to a laptop computer that recorded the data and checked it for reasonableness. The sample interval was 1 per second in all tests. The data-logger and computer were time-synchronized prior to test initiation.

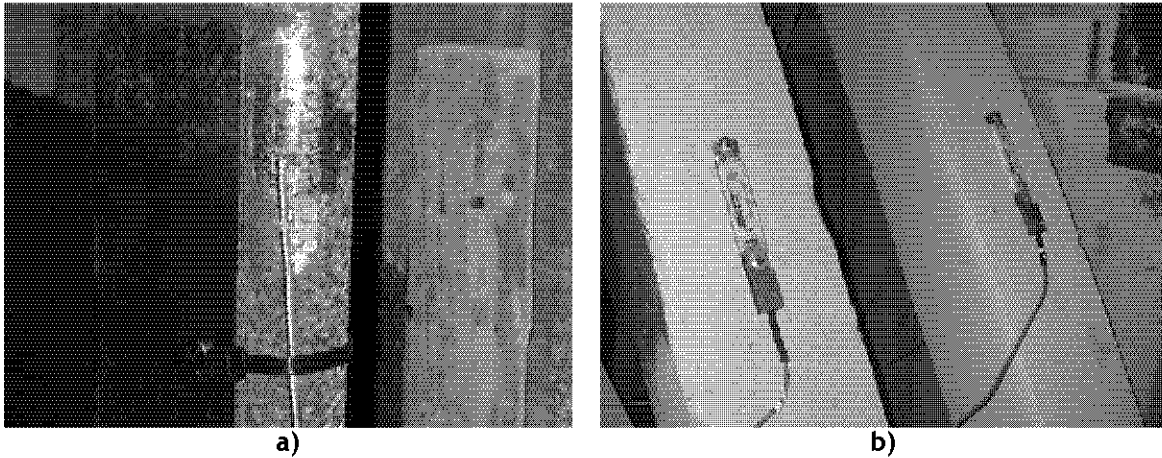
**Fig. 33: Strain gauge on a rod (a) and strain transducers on diagonal elements (b), field photograph.**

construction technique of the bridge. The strains produced by prestressing the rods were measured with strain gages (Figure 33a), in the counterbrace and the diagonal of panel L5U5-L6U6 and in the diagonals of panels L6U6-L7U7 and L7U7-L8U8, with the use of the fourteen available strain transducers. The counterbrace and both the timbers that compose the main diagonals (Figure 33b) were instrumented with two strain transducers each. These were applied on the extreme fibers of the elements, in order to evaluate the average strain and detect possible bending on the members.

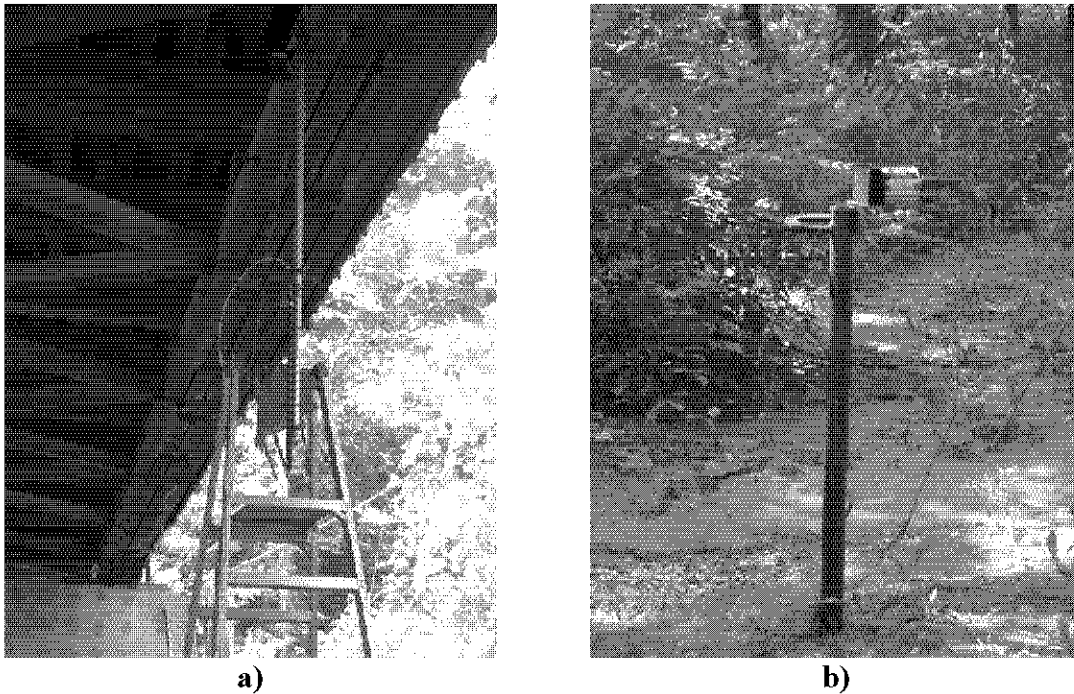
**Fig. 34: Displacement transducer (a) and potentiometer (b) used for displacement measurements, field photographs.**

Two displacement transducers and a potentiometer were placed under the northern bottom chords, at mid-span (Figure 34).

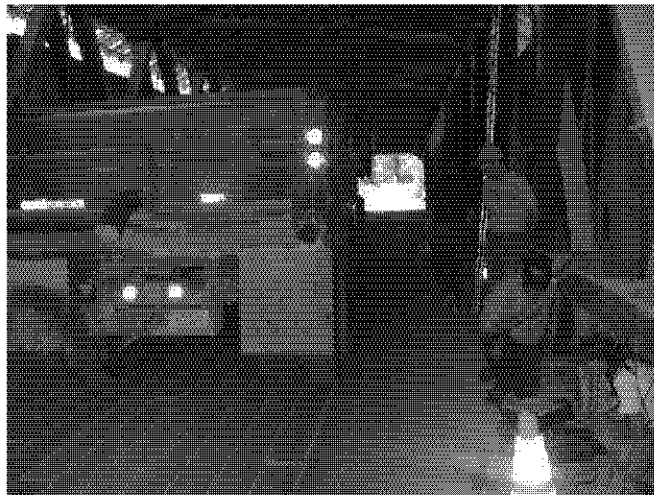
**Fig. 35: Live load testing with the 6-ton truck, field photograph.**

The live load was applied by driving a truck weighing approximately 6 tons on the bridge (Figure 35). The truck was driven along the center of the deck to avoid uneven distribution of the load between the parallel trusses, and slowly in order to minimize dynamic effects. In each test the truck was moved from north to south, and it was stopped for about 10 seconds, to allow stabilization in the DCDT data acquisition, in five different spots (L8, L6, mid-span [L5], L4, and L2).

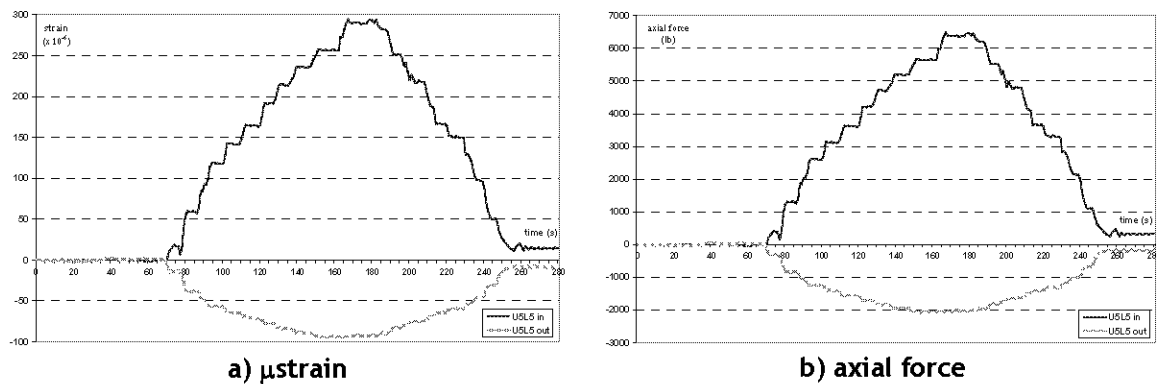
Fig. 36: Tightening of inside rod of element U5L5: strain (a) and axial forces (b) in the outside and inside rod.

Figures 36 and 37 show the results of the “prestressing test” performed, in terms of strains and axial forces produced in the rods. Note that tightening a nut on a rod of a vertical element causes a decrease of strain, that is to say a release of stress, in the other, parallel rod. In the same way, when a pretensioned rod was loosened, the other rod recovered its original strain and stress condition.

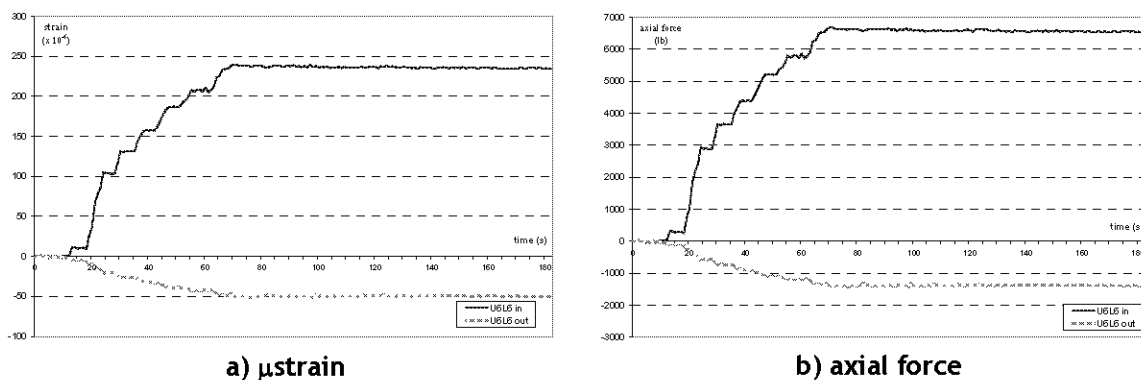
Fig. 37: Tightening of inside rod of element U6L6: strain (a) and axial forces (b) in the outside and inside rod.

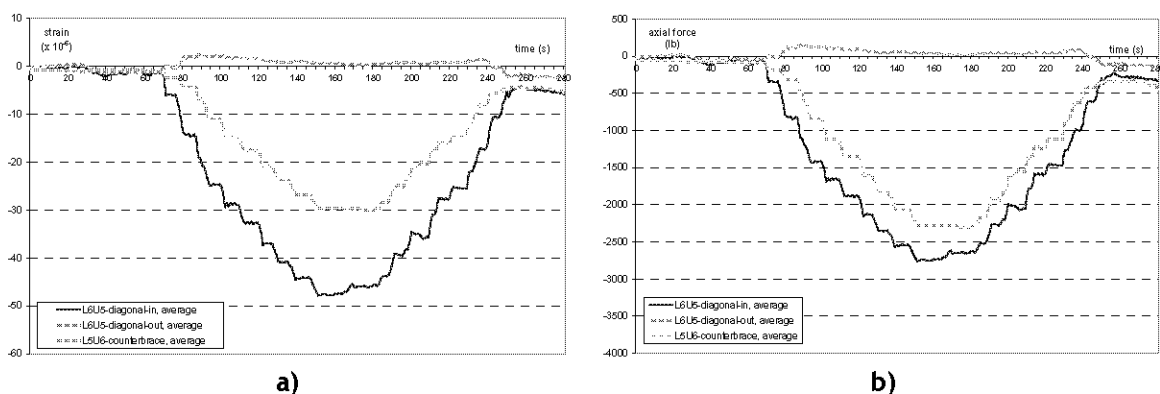
**Fig. 38: Strains (a) and axial forces (b) produced in the diagonal elements of panel L5U5-L6U6 by tightening the inside rod of U5L5.**

Figures 38 and 39 show strains and axial forces in the diagonal elements of panel L5U5-L6U6 while tightening the inside rod of L5U5 and the inside rod of L6U6, respectively. It can be clearly seen that the effect of tightening only one of the two rods of a vertical element was felt only by the corresponding main diagonal timber. The strains in the outside timbers of the main diagonals were, in fact, almost null when tightening the inside rods.

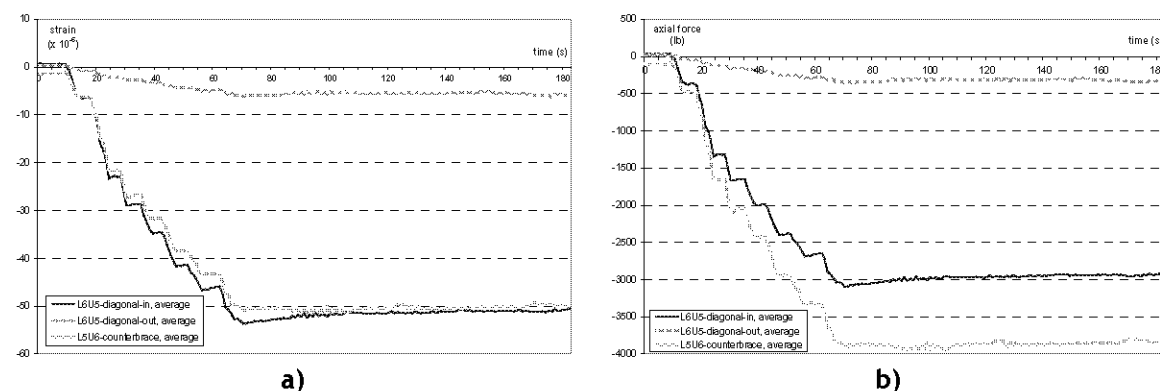
**Fig. 39: Strains (a) and axial forces (b) produced in the diagonal elements of panel L5U5-L6U6 by tightening the inside rod of U6L6.**

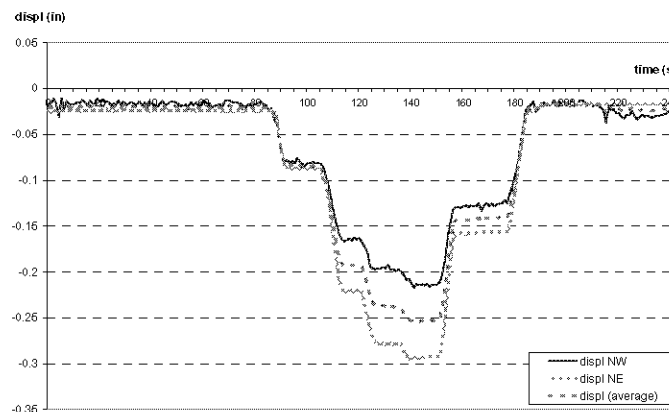
**Fig. 40: Mid-span displacements under live load.**

The average displacements of the north chord when the live load was applied at mid-span were of about 0.216 inch the three tests performed. In particular, the northeast mid-span displacement was about 17 percent higher than the northwest displacement in the tests with the truck close to the center of the deck. The initial non-zero reading of displacement was subtracted to obtain the actual mid-span displacement values.

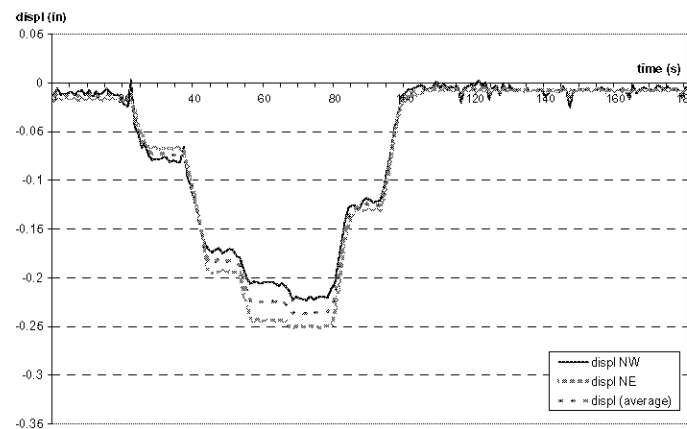
**Fig. 41: Mid-span displacements under live load with the truck close to the center of the deck.**

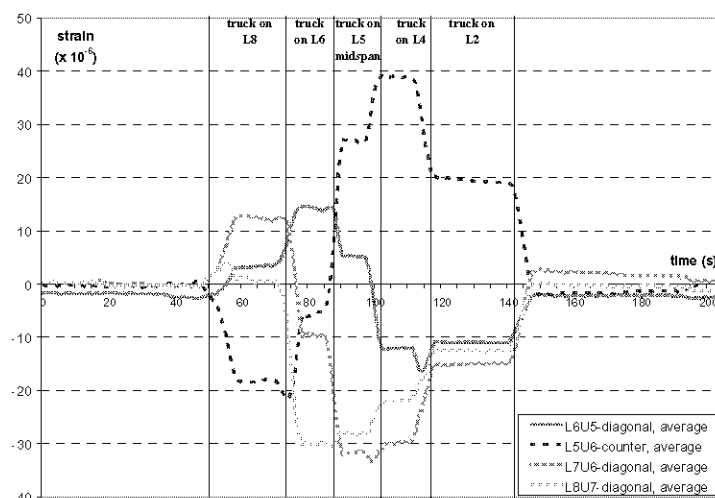
**Fig. 43: Average strains in the diagonal elements of the truss under live load, (strains from prestressing are not added).**

Figure 43 shows the evolution of average strain in the various elements instrumented with strain transducers, as the live load traversed the bridge. In this diagram the previous strains due to the prestressing have not been considered. The necessity of proper prestressing to keep the counterbraces active in compression under live loads, is again clear.

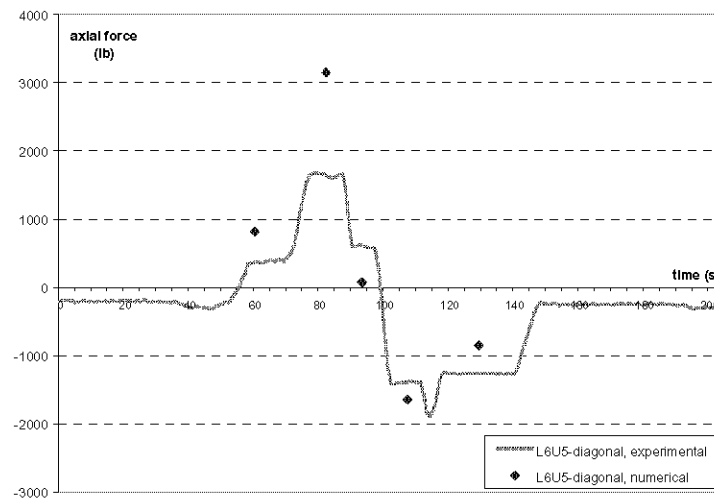
**Fig. 46: Experimental and numerical influence lines of diagonal L6U5. The numerical influence line has been obtained running a model with only counterbrace L5U6 active.**

Figure 44 shows the axial forces in diagonal L6U5 as a function of load position, as measured on site (the measured strains were multiplied by the assumed modulus of elasticity and the section area of the element) and as predicted by numerical modeling. A different model, with only counterbrace L5U6 active, was used to simulate the actual condition of the bridge, since only vertical rods L5U5 and L6U6 were tightened. It can be seen that, at least for diagonal L6U5, the model correctly predicted the anomalous behavior experimentally observed.
